## JO-1 hose-end swivel inspection recommendations

## SMAC-1 hose-end swivel inspection recommendations

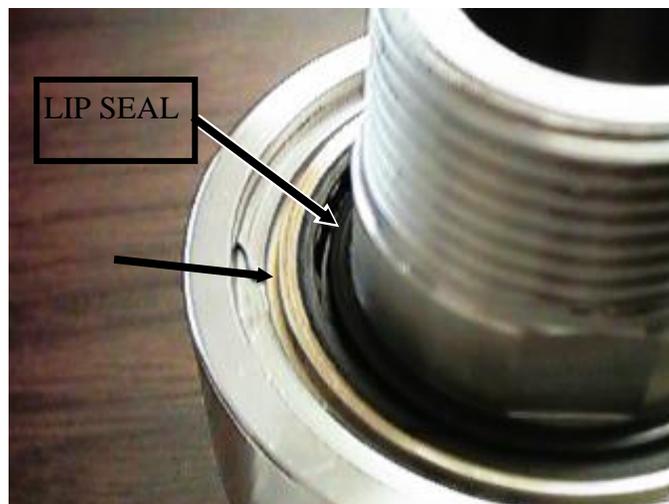
Normal retaining ring seat (note the distance between the inside diameter of the retaining ring and the shoulder of the bearing retainer plate)

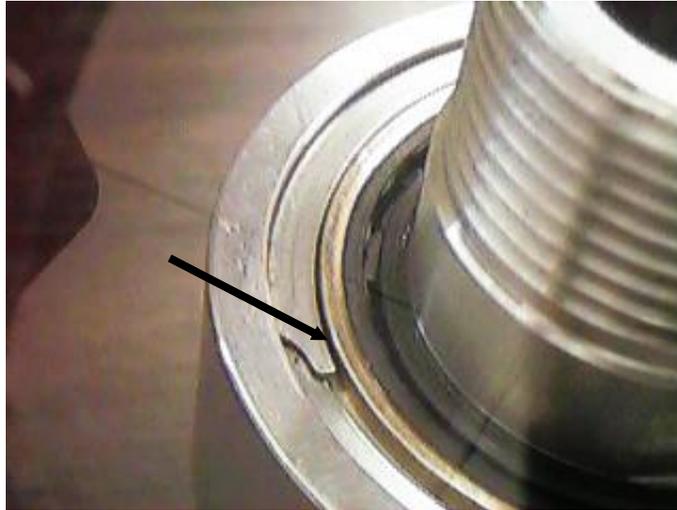
- 3.) Retaining rings in factory shipped JO-1 swivels are 100% inspected to ensure a proper fit. Because the retaining ring is deeply recessed into the end of the swivel, it would be highly unusual for the ring to become dislodged from its groove. However, proper fit should be checked periodically. Check the retaining ring at the male end of the swivel to ensure it is properly seated. Note the photographs below show a normally seated retaining ring and abnormally seated retaining ring. If the retaining ring appears to be abnormally seated, do not try to reseal the retaining ring while the swivel is installed and the system is under pressure. Remove the swivel from service and follow all directions as outlined in manuals CS-JO1 and IS-JO1. The retaining ring cannot be reseated properly unless the swivel is taken out of service and pressure is applied, such as putting the swivel in a vice and gently tightening the vice jaws. This relieves tension on the retaining ring, allowing for proper seating in its groove.

Abnormal retaining ring seat (note the minimal distance between the inside diameter of the retaining ring and the shoulder of the bearing retainer plate)-take out of service

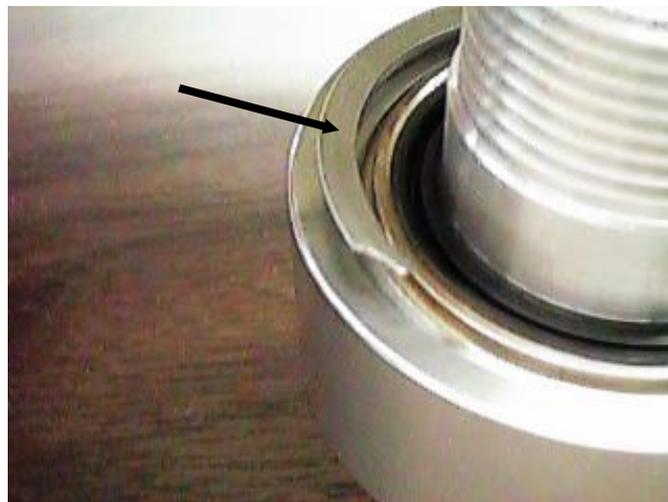
Abnormal retaining ring seat (note the retaining ring tang has come out of the retaining ring groove)-take out of service

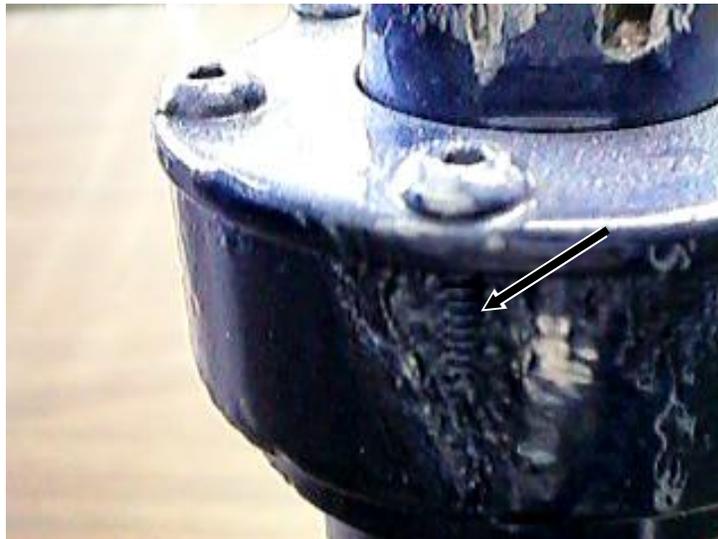
- 1.) The main housing used for the SMAC-1 is fabricated from an Aluminum alloy. In certain geographic areas, especially severe winter areas, corrosion of the main housing may be accelerated principally due to chemicals applied to roads to melt snow and ice. Cleaning chemicals may also be a factor. Visually inspect the outside of the SMAC-1 main housing to look for corrosion damage. This could be in the form of a scaly, flaky appearance, or a white powdery appearance. It is normal for the main housing to take on a light to dark gray appearance. Pay close attention to any apparent corrosion damage such as described above in the vicinity of the Drag Guard™ safety plate that is held onto the main housing with Button-head Allen screws. If noticeable corrosion damage is found, take the swivel out of service.

Note the corrosion, exposing one of the Button-head Allen screws-**take out of service**

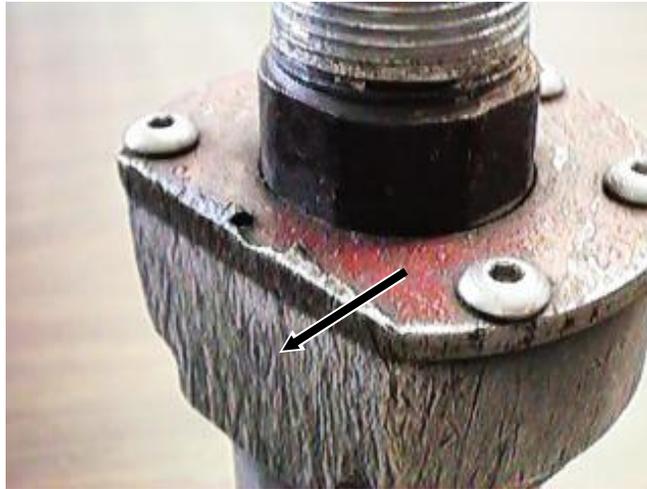
- 2.) The entire swivel can be subject to damage from dragging along the ground. Sustained dragging, such as, but not limited to the delivery hose being inadvertently dragged behind a moving delivery truck, will cause severe damage, generally to one side of the swivel. Inspect the outside of the swivel for areas that are worn flat. If one or both sides of the swivel are worn flat, take the swivel out of service. If any of the Button-head Allen screw heads are ground off, take the swivel out of service.

Note the flat-sided wear due to dragging behind a delivery truck-**take out of service**
