**PREVENTIVE MAINTENANCE INSPECTION PLAN FOR
MC-1 AND GC-1 SERIES SMITH PUMPS**

This bulletin is a supplementary addendum, which must be read in conjunction with Technical Bulletin "AL-19", and Manual "GM-1". All information listed herein, is in the same numbered section order as detailed in "AL-19". It is applicable to MC-1 and GC-1 Series pumps, as well as medium and high capacity Smith pumps, with the exception of what is stated, below. Always disassemble and reassemble the pumps in a safe, approved manner following all applicable instructions in "AL-19", "GM-1", and other literature such as "AL-1", "AL-17A", "AL-45" (N₂O), "AL-99", and "AL-201". Reseal the casings properly. Contact the factory if there are any questions.

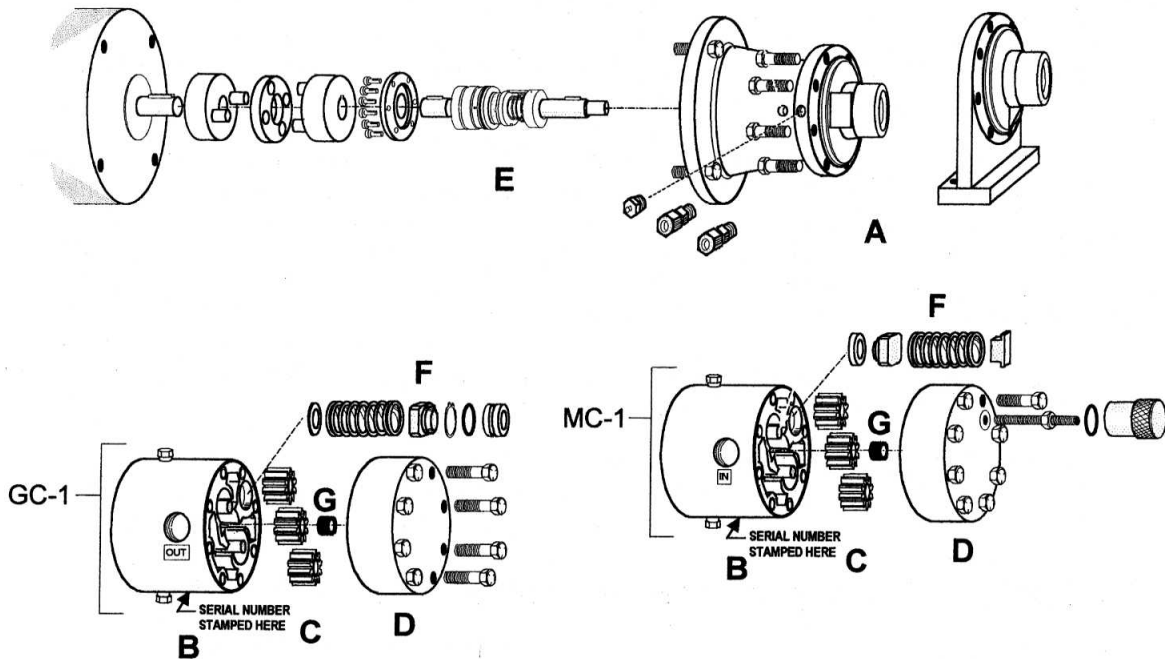
3. **Inspection of Idler Gear Bushings.** MC-1 and GC-1 Series pumps each have two idler gears per set (C) as illustrated on the following page. The proper i.d. of the carbon-graphite idler gear bushings in all idler gears after installation is 0.378 inches (9.60 mm.). If the sizes as measured do not exceed 0.379 inches (9.63 mm.), there has been very little wear and the bushings need not be replaced. If the sizes as measured exceed 0.379 inches (9.63 mm.) after such a short first interval of use, it will be important to examine the piping system and its operation to find the cause of such wear, which is excessive. When the idler gear bushings have worn to a diameter approaching 0.381 inches (9.68 mm.) or greater, the complete gear set must be replaced.

4. **Inspection of the Gears.** The proper width of new MC-1 and GC-1 Series gears (C) is 0.747-0.748 inches (18.97-18.99 mm.). Used gears measuring greater than 0.746 inches (18.95 mm.) can be reused (see gear inspection procedure in repair manual "GM-1").

5. **Recommended Procedure if Excessive Gear Wear Is Detected.** No Changes.
6. **Inspection of Idler Gear Shafts.** The proper diameter is 0.375 inches (9.53 mm.). If the measured diameter of a worn area is less than 0.374 inches (9.50 mm.) the shafts assembled in (B) as illustrated on the following page, must be replaced.

7. **The Mechanical Shaft-Seal Assembly.** All mechanical shaft-seal assemblies (E) should be frequently checked for leakage. Under normal conditions, the mechanical shaft seal assembly for MC-1 and GC-1 Series pumps should be replaced after 8,000 hours of use. However, it may have to be replaced sooner, especially if it leaks, or a worn bushing contact surface is detected. The ball bearing, which is one of the components of the Smith mechanical shaft-seal assembly, should be checked as part of the recommended visual inspection (see "AL-201"). The grease seal should be removed, and the ball bearing checked for grease. We recommend a 30% grease pack. The grease utilized in the ball bearing is "Beacon 325".

Also, be sure to carefully examine the supported end of the drive shaft for wear. If the diameter of the area has visible wear patterns, or is worn to less than 0.374 inches (9.50 mm.), the shaft-seal assembly must be replaced.

8. **Main Shaft Bushing.** The main shaft bushing (G), "649-11" is installed in the gear end cover ("D"). This carbon-graphite "journal bearing" will crack if tapped into position. It must be pressed into place, and will then acquire the proper internal diameter, 0.378-0.379 inches, or 9.60-9.63 mm., as long as the corresponding bore is not overly enlarged. Bushings with visually detectable discrepancies such as one-sided wear patterns, discolorations, or circumferential cracking, must always be replaced. There should be at least 0.002-0.003 inches (0.05-0.08 mm.) clearance between the internal shaft end diameter, and the i.d. of the corresponding bushing. If the main shaft bushing measures greater than 0.380 inches (9.65 mm.) it should be replaced.

9. **Inspection of Internal Bypass Valve Components.** These parts (F) should be visually checked during every scheduled inspection. If they do not form a positive seal, the pump will not function efficiently.

10. **Later Inspections.** No changes. Check for subsequent casing wear in items (B) and (D) in the illustration, below. See Manual "GM-1" for additional information on this and all other related aspects of concern in this procedure.
