REPAIR MANUAL FOR "GC-1" AND "MC-1" SERIES LOW-CAPACITY SMITH PUMPS

This manual contains valuable repair information for the "GC-1" and "MC-1" model types including the following use-specific modifications: "GC-1", "GC-1 L", "GC-1 LZ", "NS", "SA", "NSSA" and "S" versions of the same; "MC-1", "MC-1 L", "MC-1 LZ", "NS", "SA", "NSSA", and "S" versions of the same. Proper procedures are mentioned for changing a mechanical shaft-seal assembly, idler gear shafts, gear set, and bypass valve parts. This manual is an addendum to other repair manuals, parts views, illustrations, and parts lists.

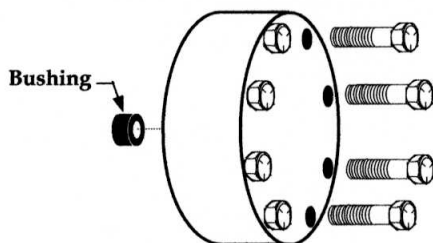
Figure 5. Main Shaft Bushing for Cover "649-11".

Before placing the gear end cover over the end of the main housing, check the condition of the main shaft bushing installed in the center of the gear end cover. The internal surface should not be worn, or cracked. It should have a tight sliding fit (0.002 - 0.003 inches) (0.05 - 0.08 mm) on the end of the drive shaft. The old bushing can be chipped-out if done carefully in order not to damage the bore surface. The new bushing must be installed with a press, being careful to maintain proper alignment while pressing it into position, slightly below the sealing surface.

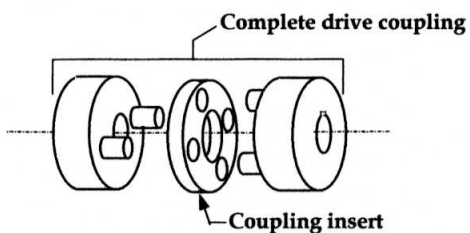
Figure 6. Drive Coupling "VC-20" with Coupling Insert "FD-20".

Once the seal assembly has been properly installed into the housing, insert the screws through the bearing retainer plate, and tighten them securely. Also, since the drive coupling is inside the shaft end cover and not visible from the outside for inspection, this is a good time to inspect the coupling and the coupling insert. If they are damaged, replace them.

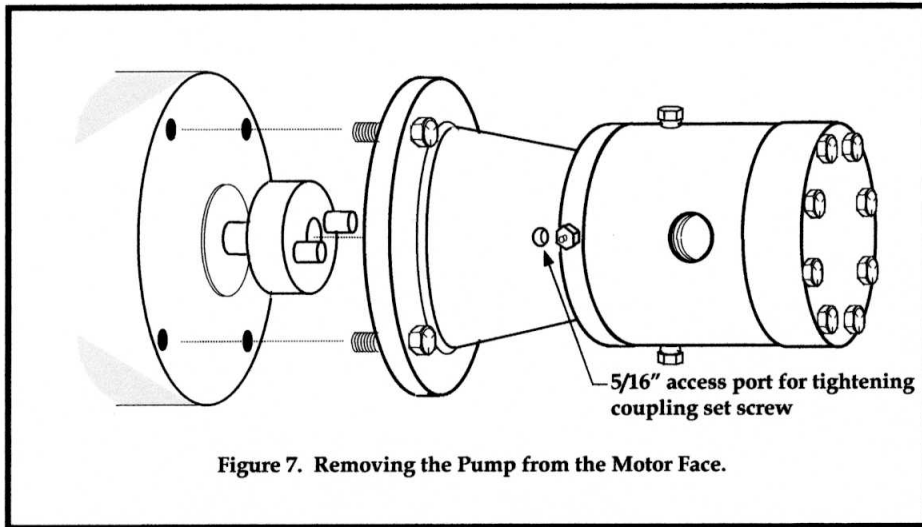
Figure 7. Removing the Pump from the Motor Face.

Separate the pump and motor. Four bolts hold the pump onto the motor. These bolts pass through the mounting flange of the pump shaft end cover and screw directly into the motor face.

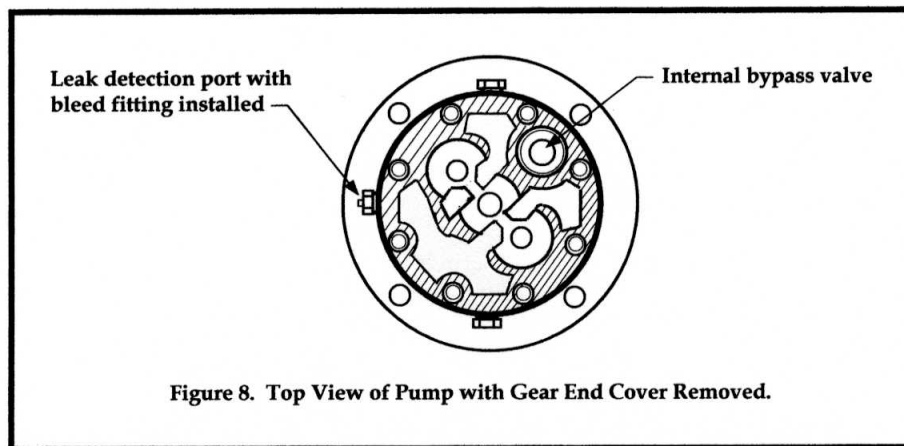
Closely examine the inside of the shaft end cover from which the shaft-seal assembly was removed. A protective device is installed in the "leak detection port" or "bleed exit" from this area. Since it is open to the outside, a certain amount of excess paint from the installation, grime, rust, or dirt can become lodged in this seal bleed exit area. If the bore appears dirty, carefully remove all deposits and clean the area as best you can. Fine sand paper or emery cloth may be used for this operation, taking care not to damage the machined surfaces. Be sure that the seal leak detection port is not plugged with debris or rust when reassembling the shaft-seal assembly into the pump casing.

Then slide the coupling half with the pins facing away from the bearing retainer plate, onto the shaft and move it inward until the shaft end is even with the end of the coupling bore. Insert an Allen Wrench through the 5/16" access hole in the flanged shaft end cover, and tighten securely. See "Figure 7" and "Figure 6". Install the drive gear key securely into the drive gear keyway. *Do not install the gears or the gear end cover at this point. Proceed with the internal inspection procedure, as follows.*

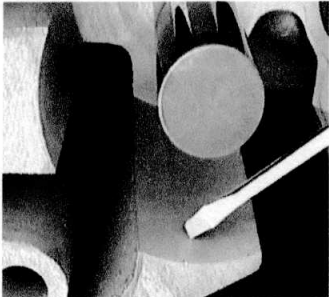
Checking for wear on the pocket diameters.

Frequently, a quick visual inspection can save time. For example, if there are visible signs of excessive material removal from the areas shown, the pump cannot be repaired. However, if there is no visible wear, the casings can be used again, and the pump can be repaired.

Since the gear end cover has already been removed from the pump, now is a good time to check the gears, idler gear shafts, casings, and bypass valve parts for wear and proper fit. First, do a simple visual casing check in accordance with the three pictures, above.

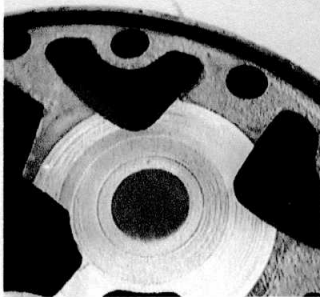
Normal gear end cover face with no functional wear.

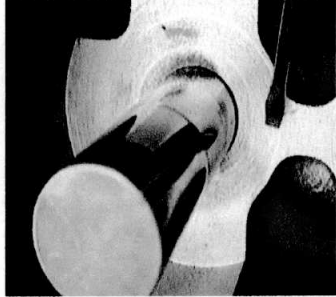
Checking for wear on the pocket ends.

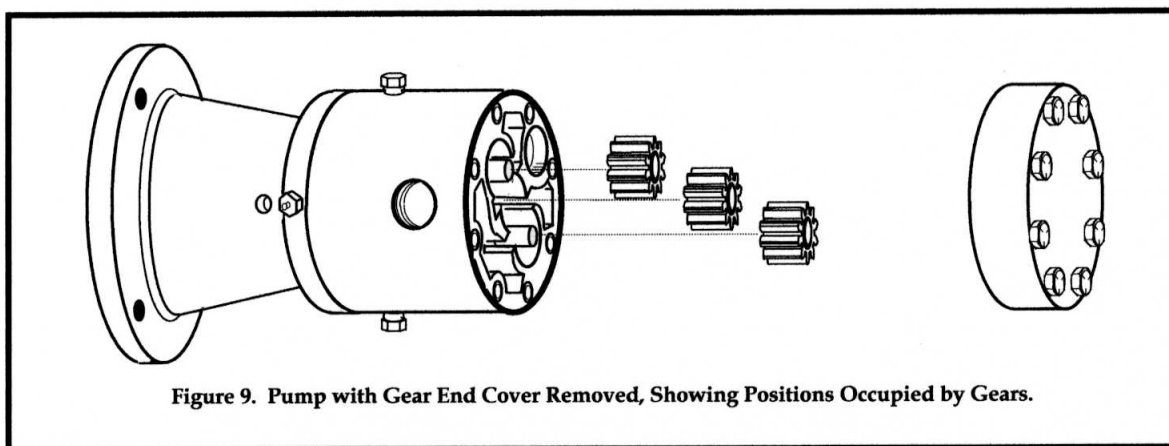
Figure 9. Pump with Gear End Cover Removed, Showing Positions Occupied by Gears.

If the casings appear to be in good condition, check the idler gear shafts, which are pressed into the main housing. Make sure that they are not worn on the side, which resists the pressure. If these pins are worn, replace them. The shaft end cover will have to be removed from the main housing, and a press with a suitable fixture is required to remove the old shafts, and install the new ones. Be sure that if this is done, the new pins are installed about .003 - .005 inches (0.08 - 0.12 mm) below the sealing face of the main housing. After the pins are replaced, be sure to clean the two mating casing faces, with a broad-bladed knife or some other such instrument. Be sure the faces are clean and flat. Apply the recommended sealant sparingly to the main housing face only. Follow the procedure under the section of this manual entitled "RESEALING THE GEAR END COVER ONTO THE MAIN HOUSING" on page 10. Be sure that the shaft end cover is oriented as shown in "Figure 9", below.

Placing a suitable tool with a straight edge across the main housing face, use a feeler gauge to measure the distance between the straight edge and the face of each gear. If there is no measurable wear by the gear faces into the gear end cover, this measurement determines the *total* gear end play. This total gear end play should never exceed 0.004 inches (0.10 mm).

Next, use two feeler gauge blades simultaneously between the left and right sides of each gear and the corresponding walls of the gear pockets. Begin with the drive gear (center gear) installed in the main housing. The sum of the two measured widths in this case should never be more than 0.005 inches (0.13 mm).

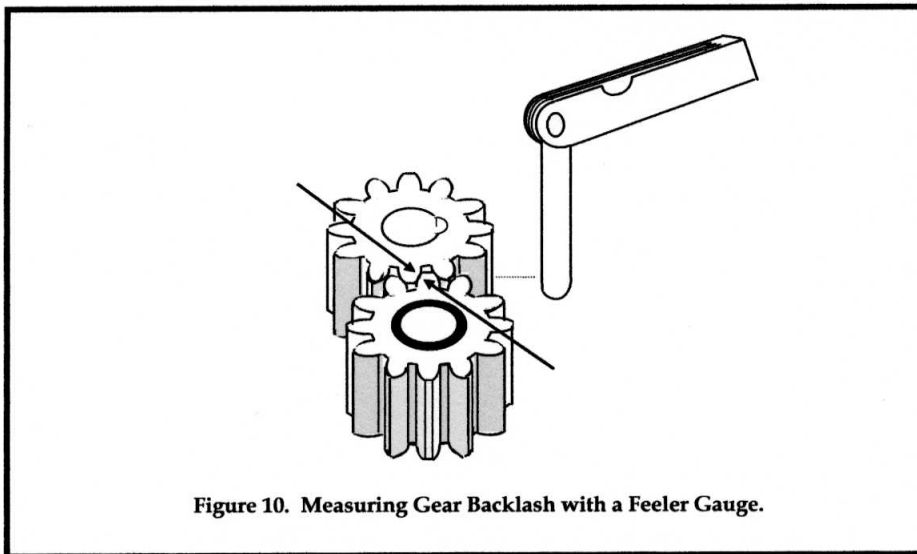
Figure 10. Measuring Gear Backlash with a Feeler Gauge.

Check the length clearance and the diametral clearance around the two driven gears in the same fashion. The maximum clearances are the same for these gears as they are for the drive gear. If the gear clearance measurements are beyond maximum, it is usually because the excessive wear on the used gear set was not noticed during the visual inspection. When this is determined to be the case, discard the used gear set, install a brand new gear set, and take all the measurements again. Once the gears have passed these two inspections, measure the "backlash". Insert a feeler gauge between the meshing gear teeth, first in the top gear combination, and then, in the bottom one, where the drive gear meshes with the two idler gears. This measurement will indicate the total amount of tooth wear and working diametral clearance. The actual maximum backlash with the gears installed in the pump is 0.016 inches (0.40 mm). Therefore, when measured with a feeler gauge, if a 0.014" (0.35 mm) gauge can be fitted between the meshing teeth, there is essentially too much clearance in the pump for an acceptable repair which will last a reasonable amount of time.¹ If the gears pass this inspection, proceed with a visual inspection of the bypass valve parts.

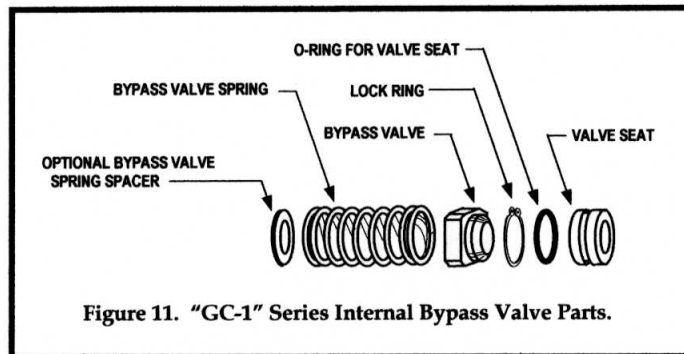
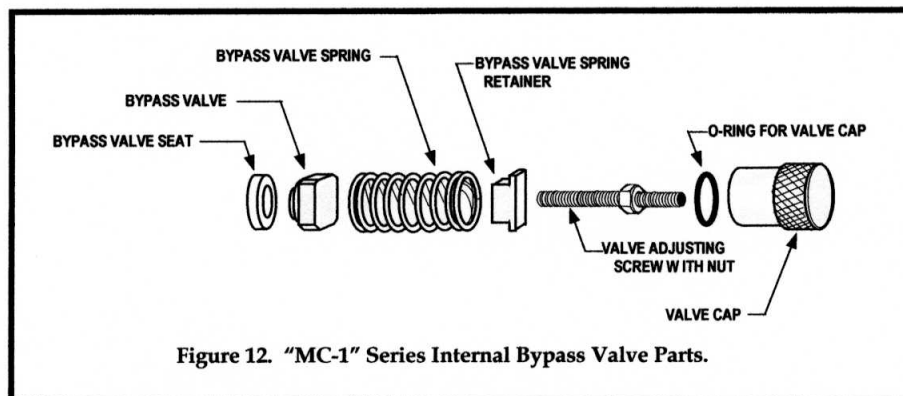
The "GC-1" Series and the "MC-1" Series have different internal bypass valve configurations. Please refer to the following drawings, "Figure 11" and "Figure 12".

Note that with the "GC-1" configuration as shown in "Figure 11", all the bypass valve parts are internal, and installed in the main housing only. With the "MC-1" configuration, the bypass valve seat, valve, spring, and spring retainer are installed in the main housing; and the remainder of the parts, the valve adjusting screw with nut, the o-ring, and the valve cap are installed on the gear end cover.

Once these steps are completed, and the bypass valve parts are determined to be in good condition, reassemble them to the casings, in proper sequence, as per the assembly drawings in "Figure 11" or "Figure 12". With the "GC-1" Series, make sure that the lock ring properly engages the groove before inserting the valve seat.
